Traditional brickwork repair

## Brickwork injection and negative-side waterproofing on the interior

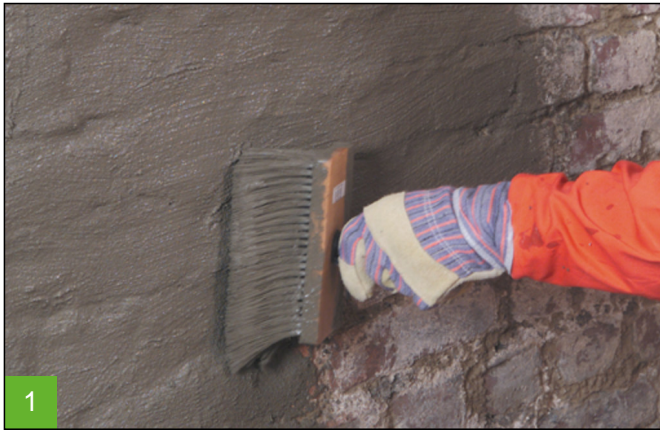
Application of the 1st layer.

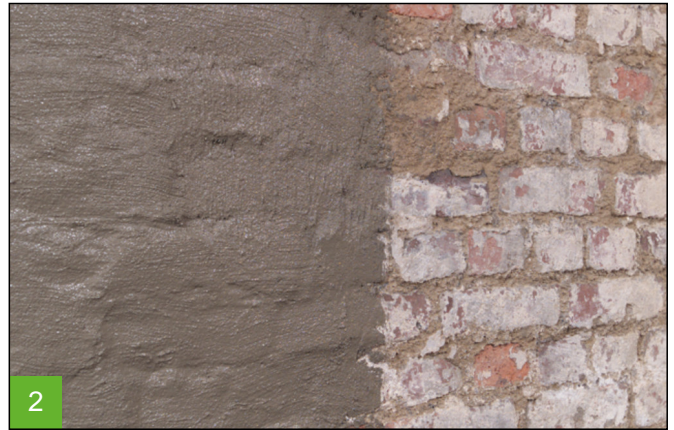
Make sure to apply 2 layers!

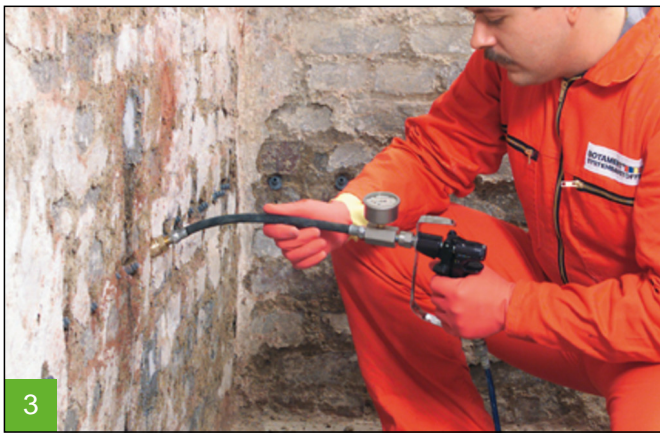
Injection with **BOTAMENT** &nbsp;**MS 10** using pump technology

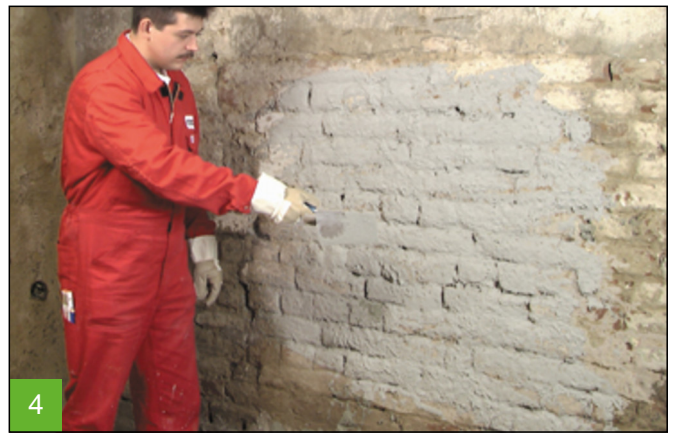
Application of the roughcast.

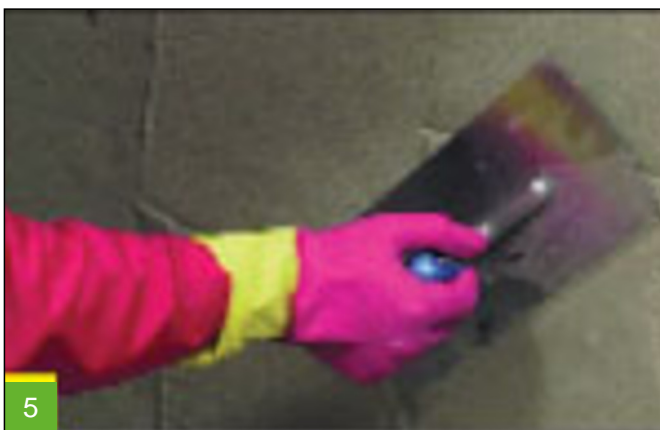
Application of the restoration render system.

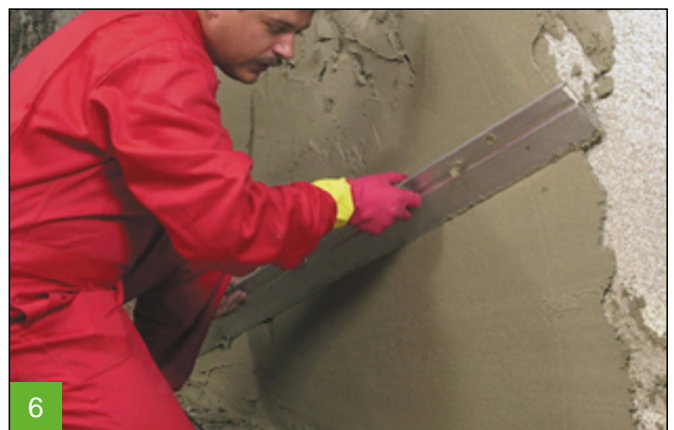
Removing any excess render and smoothing down the surface.
